# FLAP TROUBLESHOOTING

by Rick Wheldon

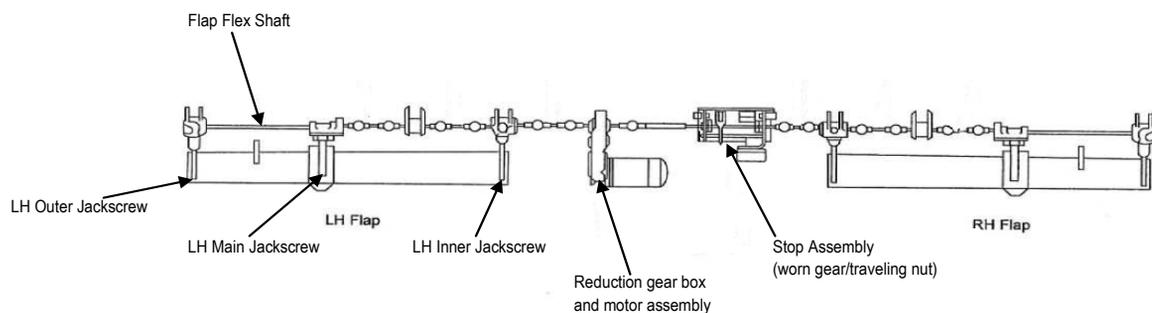
Figure 1, Flap System

Looking at the MU-2 flap system, there are 3 jackscrews on each wing, driven by an electric flap motor and a combination of torque tubes and flex cables (Fig. 1). The center “main” flap jackscrew is the largest (Fig. 2), and it performs most of the work. The inboard and outboard jackscrews mostly control alignment.

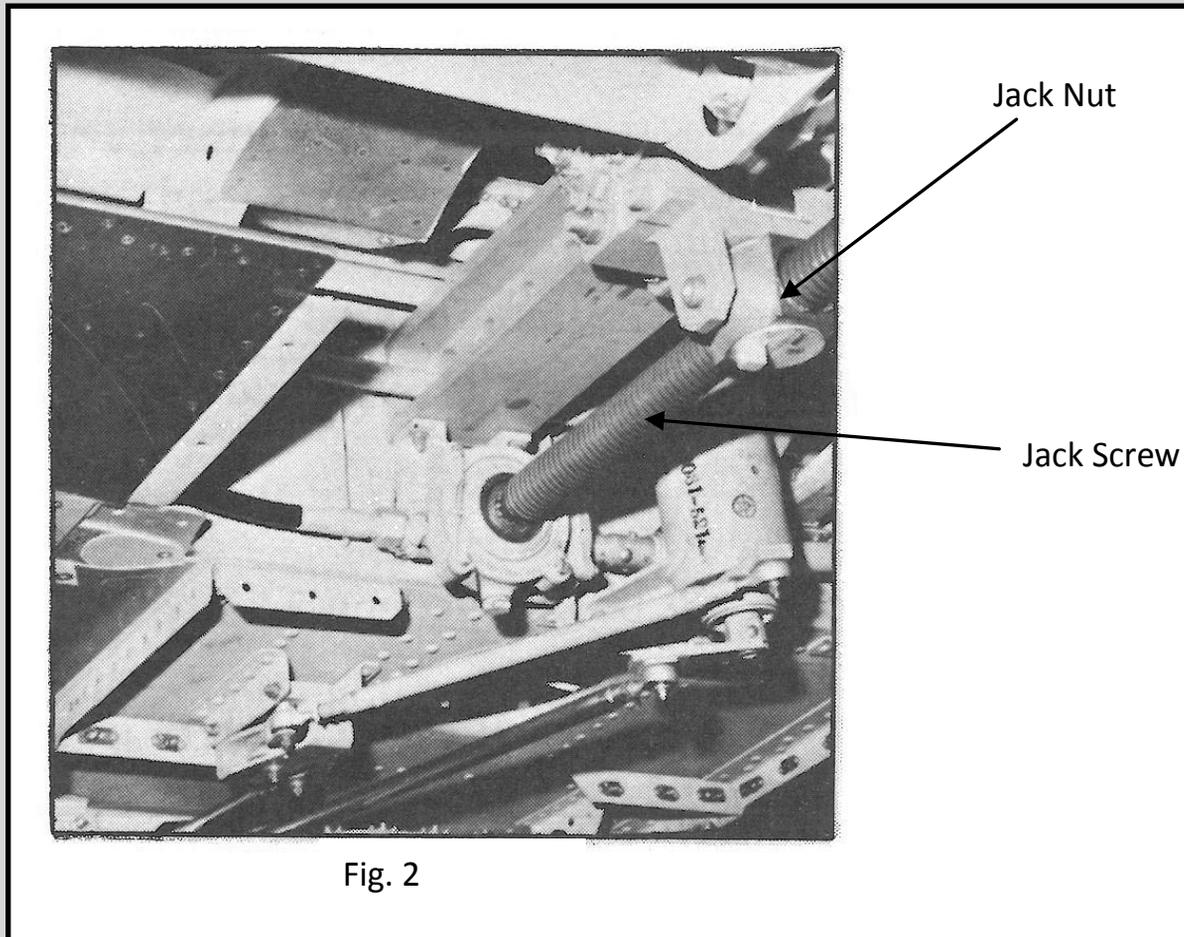
Fig. 2

What will maintenance do? The first step will be to check the tolerances on your jackscrews and jack nuts. You can get a good idea of the condition of your jackscrews and jack nuts during your preflight, when you grab the flap trailing edge (flap extended to 5° or 20°) and push it up and down. An excessive amount of play indicates that the jackscrews and or jack nuts may be excessively worn. If so, no amount of rigging will correct the problem, and the worn parts should be replaced. Most likely, if there is excessive play, the culprit is the main (center) jackscrew or jack nut,

because those carry the highest load during flap operations. Main jack nuts are checked during inspections by dropping the flaps to 40° and checking for free play at the trailing edge. Maximum movement is 7mm. If this free play is excessive, the jack nuts will have to be removed and checked further.

Main jackscrew wear is usually greatest at 20° flap extension, since this flap selection is most commonly used for takeoffs and landings. To check jackscrew wear, with the flaps at 40°, look just forward of the main jack nut. This is where the

jack nut would ride when 20° flaps are selected. If the width of the top of the jackscrew thread is less than 1.5mm, the jackscrew is excessively worn. Note that while jackscrew wear is most likely to be excessive at 20°, the entire jackscrew should be inspected.

One final reminder is that, since jackscrew and jack nut wear is such a major factor in flap operations, it follows that an operator would be prudent to minimize that wear through regular lubrication. The MU-2 inspection program calls for lubrication every 100 hours or 12 months, whichever comes first. Cutting back on your lubrication schedule could be penny wise and pound foolish.
