THE MU-2 FLAP SYSTEM

by Rick Wheldon

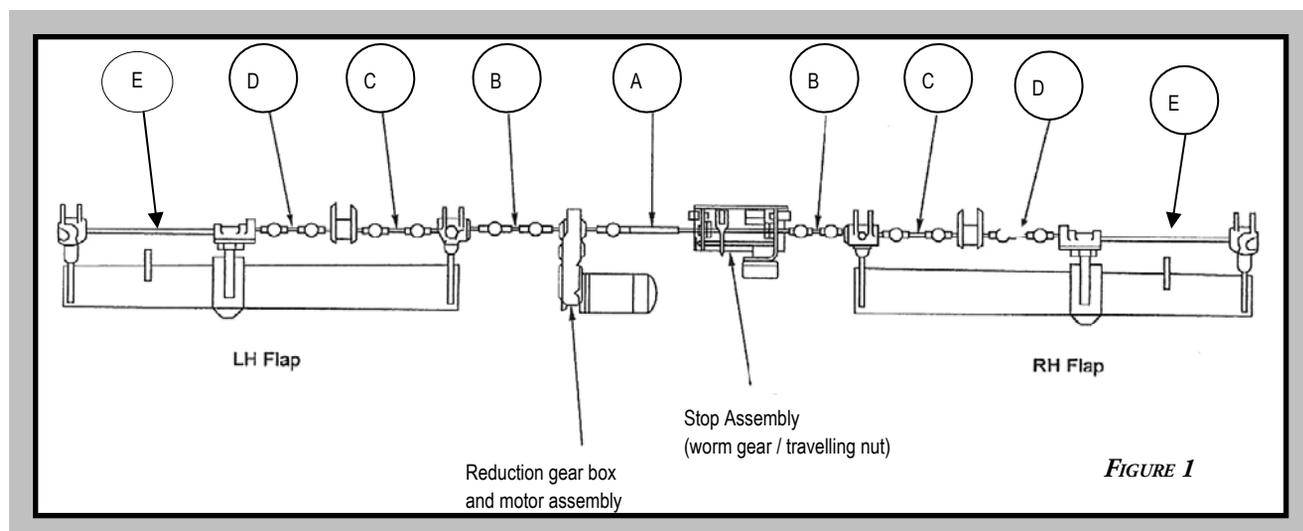
FIGURE 1

splines. Outboard of the motor on one side and the worm gear assembly on the other are two more torque tubes (B), which drive the inboard flap drives and jackscrews. Further outboard are more torque tubes (C) and (D) which transmit the torque from the inboard flap drive to the center flap drive. Farthest outboard are two flex shafts (E) that transmit the torque from the center flap drive to the outboard flap drive shaft.

If a flex shaft (E) fails, the outboard section of the flap will stop extending, while the center and inboard sections will continue to extend. This asymmetrical extension will likely result in a twisting jammed flap, which will slow, then overload the motor and pop the flap motor circuit breaker. Some asymmetry will likely result. Similarly, if any of the torque tubes between the inboard and center flap drives fail (C or D), the same twisting should result and the flap would likely jam. Cockpit indications for any of the "jammed"

What about a torque tube failure (B) between either the motor and the left inboard drive, or the worm gear/traveling nut and the right inboard drive. In this case, one flap will move and the other will not. Selecting the previous flap position in the cockpit will quickly return the moving flap to the previous symmetric position. This is the scenario in the SimCom simulator and is a good reason to let your hand linger on the flap switch when selecting a new position. Assuming one of the B torque tubes breaks as the pilot selects the new flap position, the pilot senses the roll associated with the asymmetry and places the flaps back to the previously selected position. The flaps will stop evenly at the previously selected position, and the pilot would land with that flap setting. The flap lights would indicate which flap position was selected.

Finally, what about a disconnected center torque tube (A) between the motor and the traveling nut assembly? If torque tube A disconnected when the pilot selected more flaps, the flap switches would ask for flap extension and would turn on the motor, thus extending the left flap. Because of the disconnected torque tube, the right flap would not extend. The traveling nut would not move, and the control switches would not register that the flap had reached the new selected position. Therefore, the left flap would want to keep running until it reached its max travel, past 40. Reselecting the previous flap position would reverse the motor and drive the left flap back up. (Incidentally, I don't like configuration changes at low altitude. That's one reason why I don't select flaps 40 on short final, to avoid having to deal with this type of failure close to the ground.)

of torque tube joints with improved versions, or repetitive inspections if the joints were not replaced. If not replaced, the center torque tube (A) joints required inspections every 100 hours for tubes with more than 4000 hours time in service. All other 4000 hour torque tubes required either replacement or repetitive inspections at 500 hour intervals. In practice, many operators have elected to replace the center tube joints to remove the 100 hour inspection requirements, but the manufacturer recommends replacement of all joints. With this requirement, as stated earlier, there has
