MU-2 LANDING GEAR SYSTEM

by Rick Wheldon

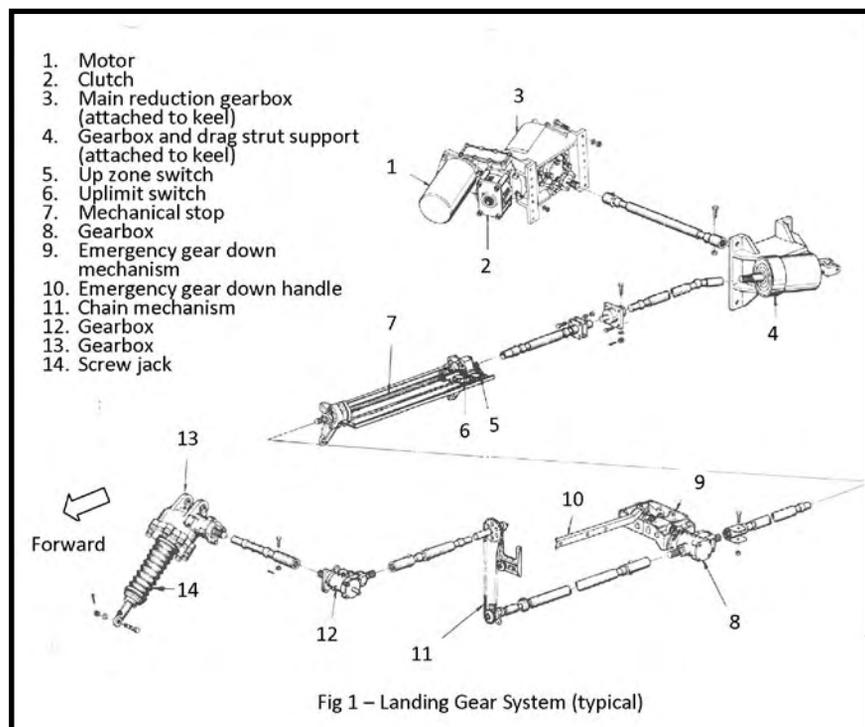
One incident happened about twelve years ago. After takeoff, the right main gear retracted but the left and nose gear remained extended. In this incident, the bolts that connected the gearboxes to the keel frames came loose (*see gearboxes, parts 3 and 4 in Fig 1*). This allowed the torque tubes between the left and right main gear to disconnect during taxi out. When the gear was subsequently raised after takeoff, the right gear retracted normally, but the left and nose gears remained extended because of the disconnection of the torque tubes between the right and left gearbox caused by the loose bolts. Since the linkage to the left gear and nose gear was disconnected, the travelling nut (from which most of the gear sequencing micro-switches are activated) remained in the DOWN (full forward) position, and, of course, the nose landing gear downlock switch also remained in the down position. Sensing that the landing gear was already DOWN, power could not be applied to the gear motor to lower the right gear, and it remained in the UP position.

The subsequent emergency landing was handled well, the engines were feathered just prior to touchdown, and relatively minor damage resulted to the tip tank and right cowling. After this incident, Mitsubishi issued a Service Bulletin and revised the inspection manual to require regular torque checks on the bolts connecting the gearboxes to the airframe, and this problem has not recurred.

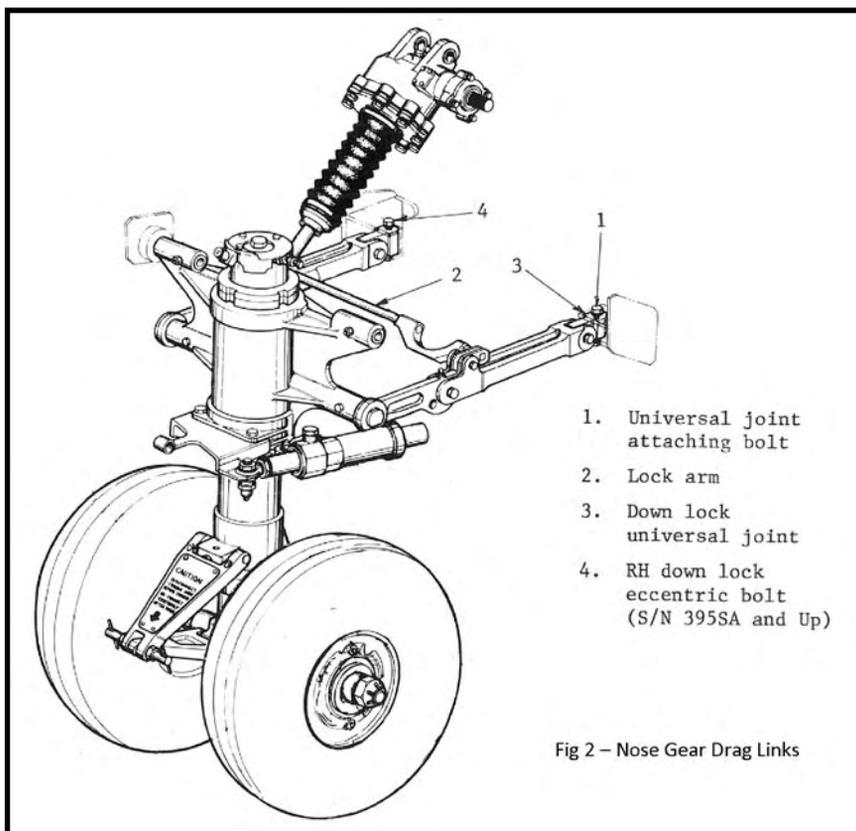
Fig 2 – Nose Gear Drag Links

Another issue that has been observed recently is incorrect rigging of the nose landing gear, primarily on short body aircraft, but potentially on long body aircraft as well. There have been three incidents of nose gear collapse, all caused by improper adjustment or installation of incorrect parts. The nose landing gear has two drag struts installed, one on each side of the trunnion (*Fig 2*). These drag struts support the gear in the down locked position, and must both be fully and evenly extended when the gear are down. To ensure even extension, a universal joint attached to the rear of each drag strut must be properly fitted. Unfortunately, in two of the collapse incidents, the wrong part number universal joint was installed. The third collapse was caused by installation of an incorrect drag strut link.

One symptom of an improperly adjusted drag strut is a "popping" sound from the drag strut. If you ever hear this popping sound from the nose wheel area during gear retraction or extension, you are obviously going to have to land, and a nose gear collapse is unlikely, but you shouldn't make any further flights until the gear are checked out by an MU-2 experienced mechanic. Repeat-

ed landings with these symptoms can eventually lead to collapse. This is the time to consult one of the experts at the MU-2 Service Centers. Because there have been several incidents where the wrong parts were installed in the nose landing gear, it might be prudent to have your maintenance facility go over the system thoroughly, paying particular attention to the rigging and operational checks. Service News 062 deals with nose gear rigging for short model aircraft and, when referenced in conjunction with the maintenance manual, will ensure proper rigging and adjustment.
